North Park Lake Aquatic Ecosystem Restoration Project

by James A. Kosky, P.E.¹

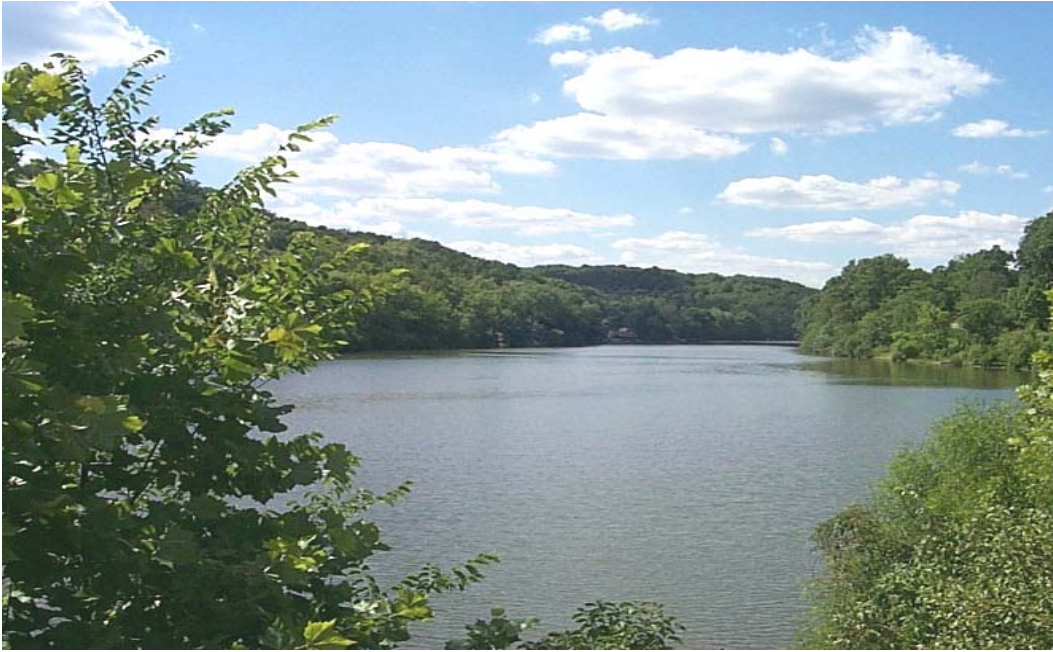
Figure 2. North Park Lake

North Park Lake is located in Allegheny County's North Park about 10 miles north of the city of Pittsburgh, Pennsylvania. In 1935, Pine Creek Dam was constructed to impound 568 acre-feet of water to form North Park Lake. Two forks of Pine Creek referred to as North and South Fork Pine Creek form the lake. North Park and Pine Creek Dam are owned and operated by Allegheny County. The park and lake provides recreation including fishing, boating, picnic groves, baseball fields, tennis courts, walking trails, a swimming pool, golf course and much more for people to enjoy. It is heavily used in the summer time with over 240,000 people renting picnic shelters and buildings. Millions of people enjoy the lake and park each year. Some of the winter activities include ice-skating and ice fishing. Figure 1 is a location map of the general area with respect to the U.S. Army Corps of Engineers Pittsburgh District Plan of Development map. Figure 2 is a photograph of the lake looking upstream standing on top of the dam.

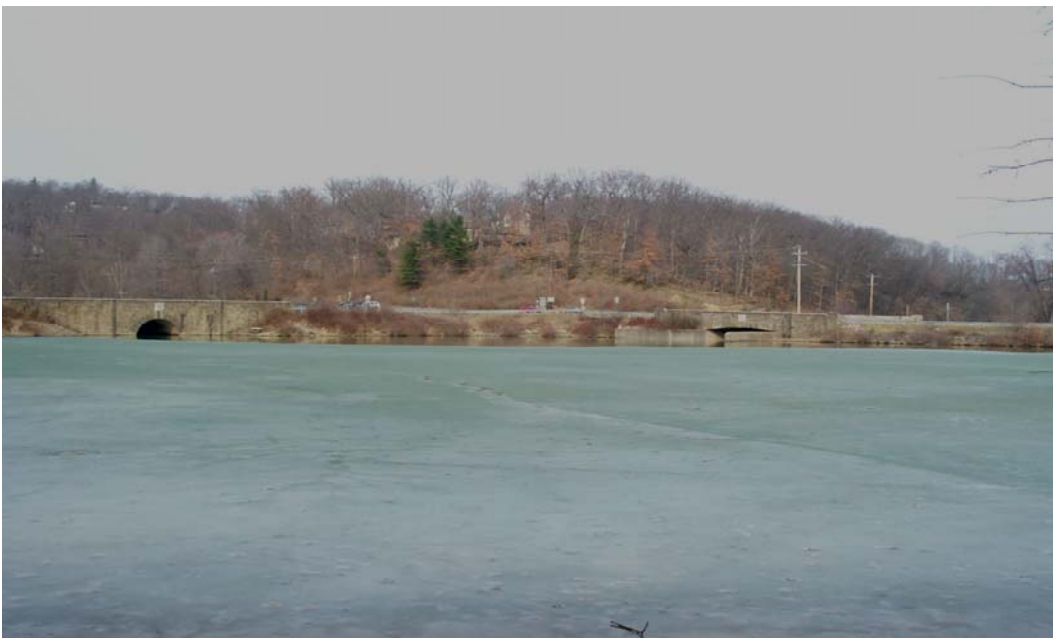
Figure 3. Pine Creek Dam

Pine Creek Dam is 33 feet high, approximately 1,130 feet long, has a 60-foot wide spillway crest and is located on Pine Creek. It has an uncontrolled spillway set at 10 feet below the top of the dam. The outlet works consist of an intake tower with a manually controlled 5 foot by 5 foot sluice gate which has not been operated recently. Table 1 shows pertinent information about North Park Lake and Pine Creek Dam and Figure 3 is a photograph of the dam.
